**FINAL REPORT  
FOR  
TF30 THIRD-STAGE COMPOSITE FAN BLADE  
SERVICE PROGRAM  
Contract No. F33657-70-C-0624**

David G. Randall  
Pratt & Whitney Aircraft Group  
United Technologies Corporation  
East Hartford, Connecticut 06108

15 May 1978

Final Report for Period 1 July 1970 – 31 December 1977

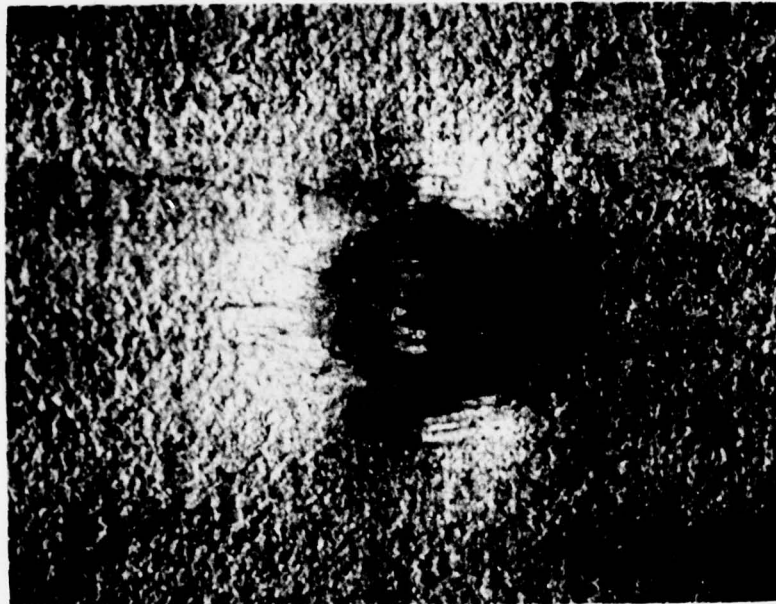
Ballistic impact damage was achieved with a 0.67 gm pellet fired from an air pistol at a velocity of 500 ft/sec. The resulting damage is shown in Figures 9.2-3 and 9.2-4. To assess the extent of damage produced by impacting, ultrasonic C-scan inspection was performed, as illustrated by Figure 9.2-5.

*Figure 9.2-3 Ballistic Impact Damage on a Unidirectional Borsical<sup>®</sup> Test Panel Specimen, SAR-Bs/A-3A/u-H2*

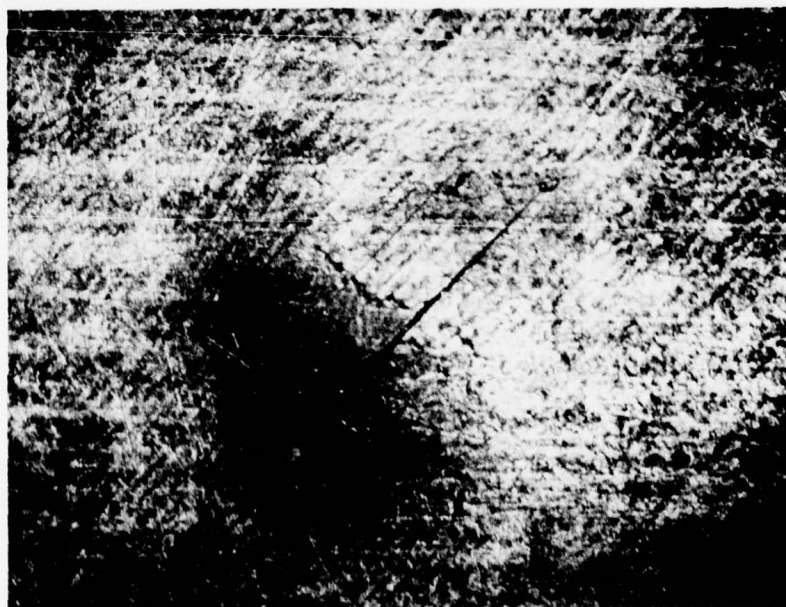
*Figure 9.2-4 Ballistic Impact Damage on a Component Borsical<sup>®</sup> Test Panel Specimen, SAR-Bs/A-7B/B-H3*

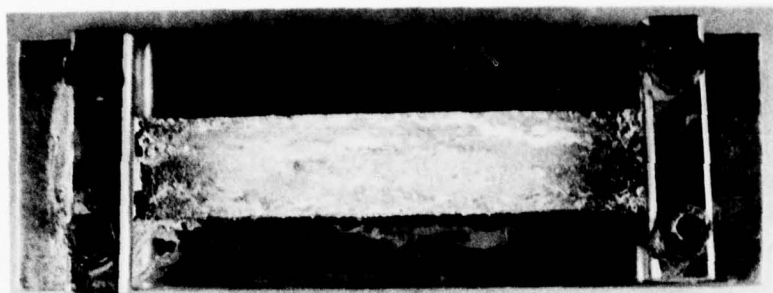
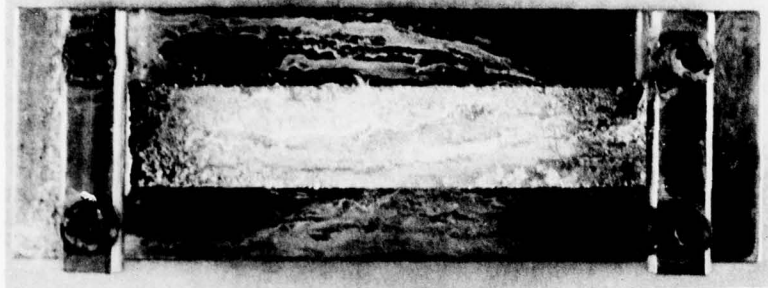
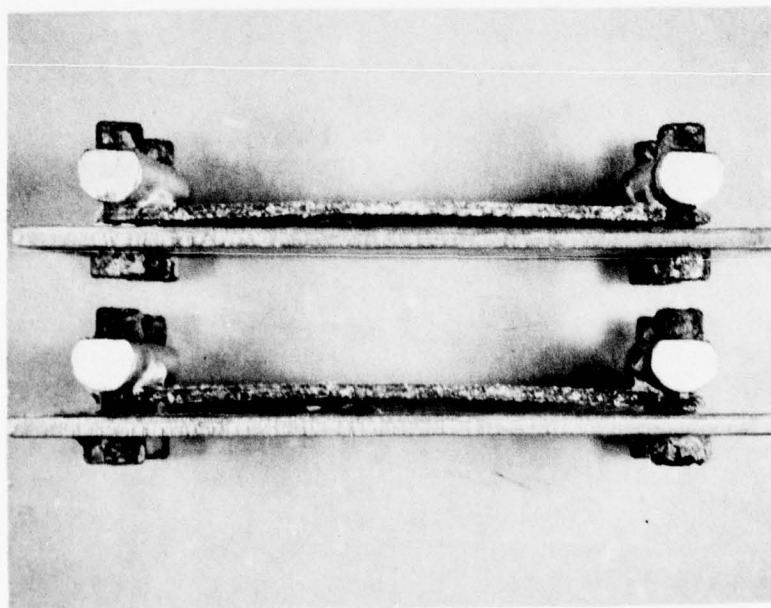
Figure 9.2-5 Ultrasonic C-Scan Traces of Typical Ballistic Impact Borsical<sup>®</sup> Specimens

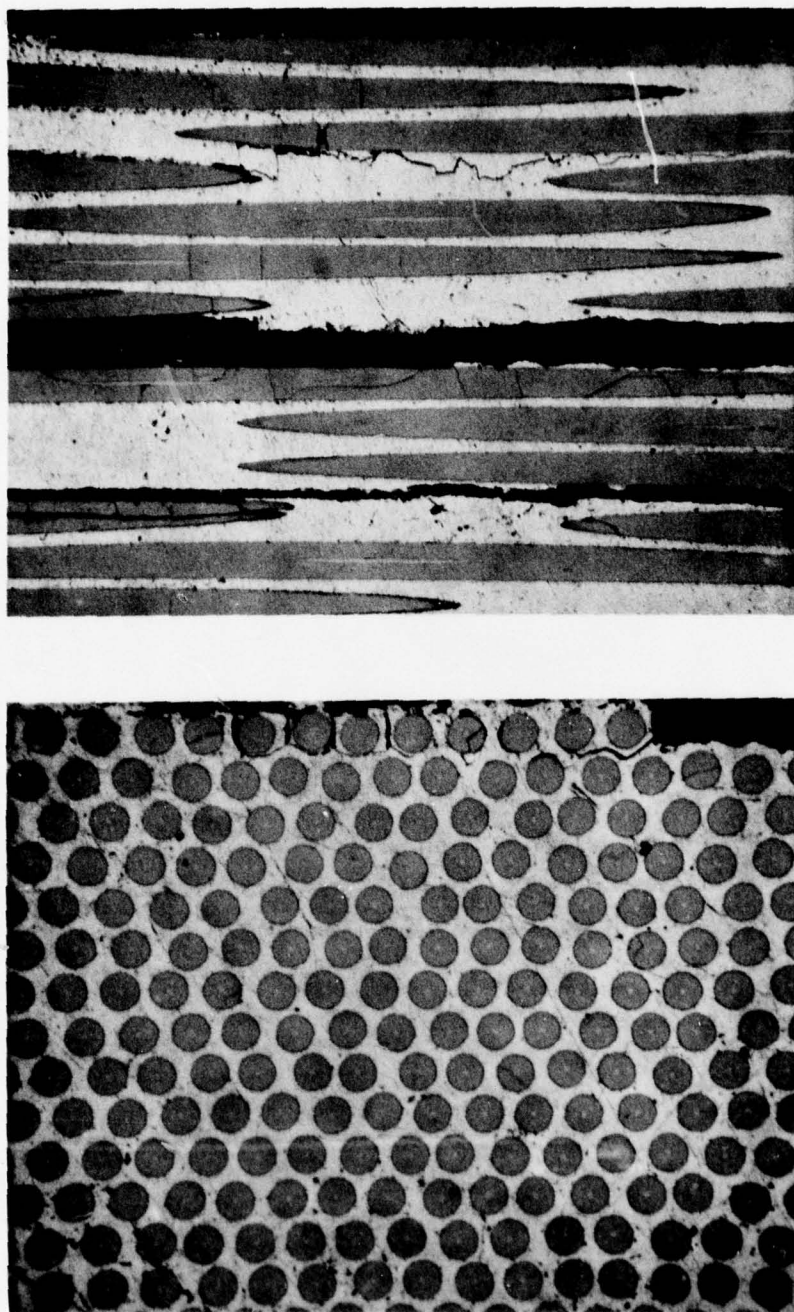
Figure 9.4-4 Microstructure of Unidirectional Borsical<sup>®</sup> Specimens that were High Frequency Fatigue Tested at 70°F and 3100  $\mu$  in./in. for  $2 \times 10^6$  Cycles (2E/u-H2 at Left) and  $3 \times 10^6$  cycles (1D/u-H4 at Right)

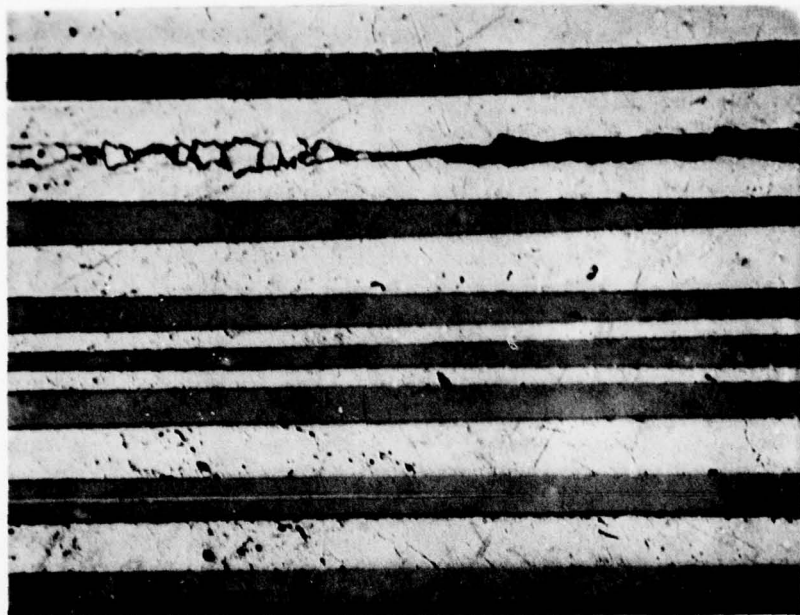
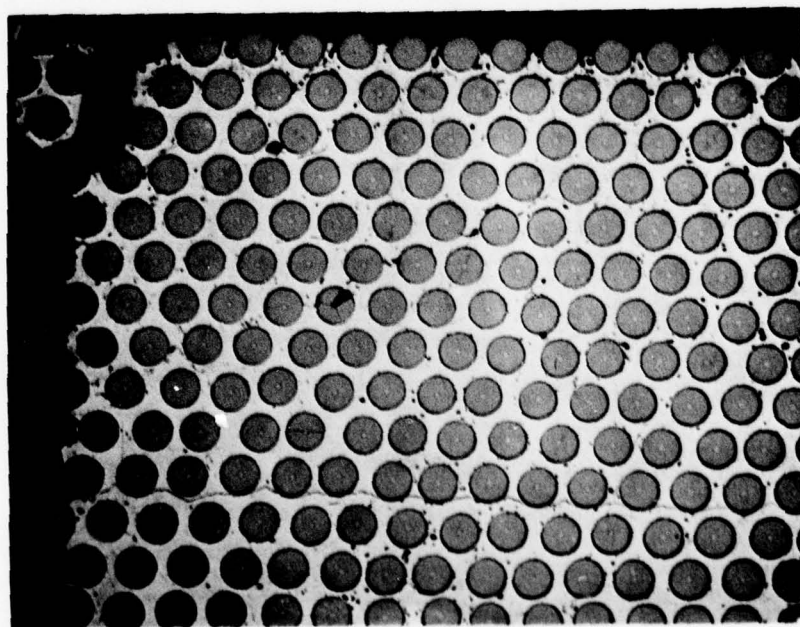
Figure 9.4-5 Microstructure of Unidirectional Borsical<sup>®</sup> Specimens that were High Frequency Fatigue Tested at 70°F and 3100  $\mu$  in./in. for  $5 \times 10^6$  Cycles (1E/u-H3)

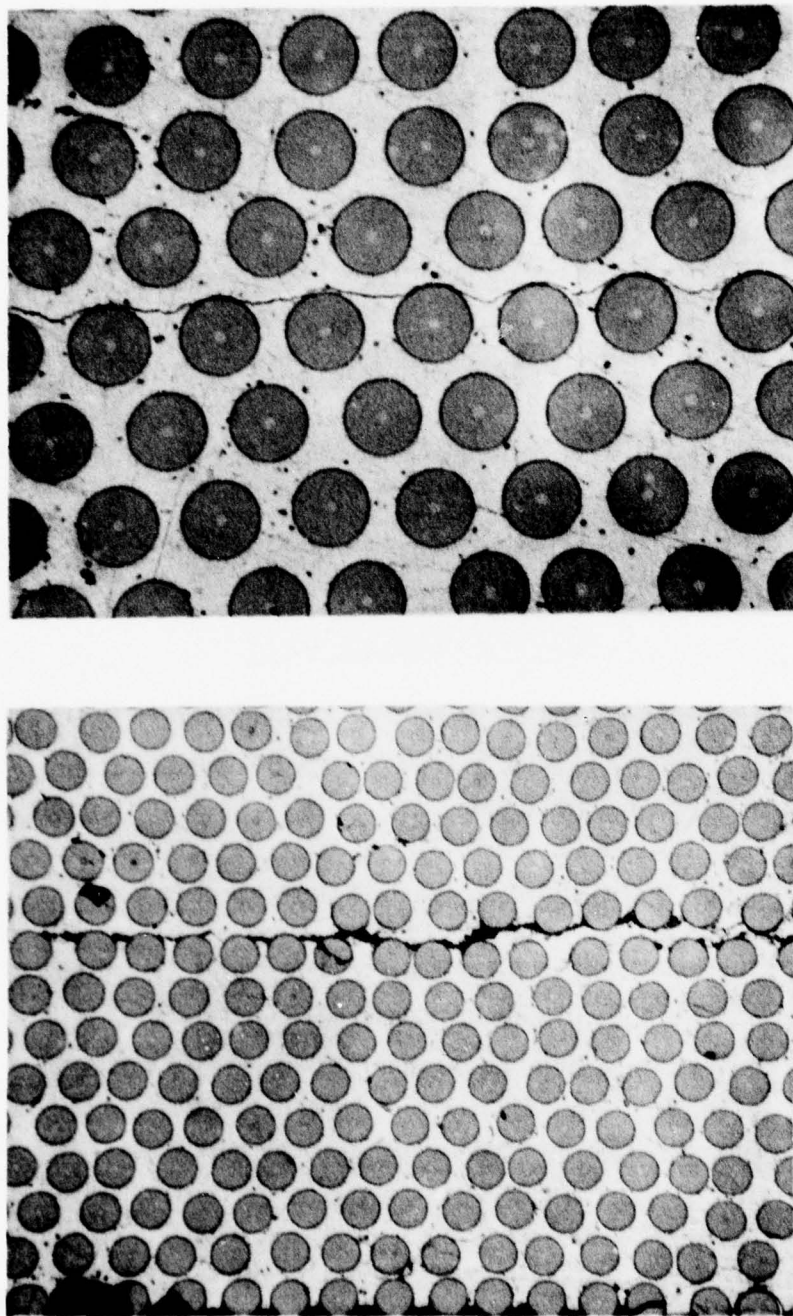
At 450°F the HFF failures of unidirectional specimens did not differ greatly from those tested at room temperature. At this higher test temperature, lower strain levels were used, but the basic failure modes were unchanged. Failures consisted mostly of surface delamination (Figure 9.4-6) with some internal delamination between middle layers, and a few cracks (Figure 9.4-7). Differences between microstructures for the various HFF life fractions were not found, and all unidirectional specimens had similar internal defects regardless of test temperature or percent of life exhausted.

Figure 9.4-7 Microstructure of Unidirectional Borsical<sup>®</sup> Specimens that were High Frequency Fatigue Tested at 450°F and 2100  $\mu$  in./in. for  $5 \times 10^6$  Cycles (3D/u-H3 at Left) and 2220  $\mu$  in./in. for  $2 \times 10^6$  Cycles (11E/u-H3 at Right)

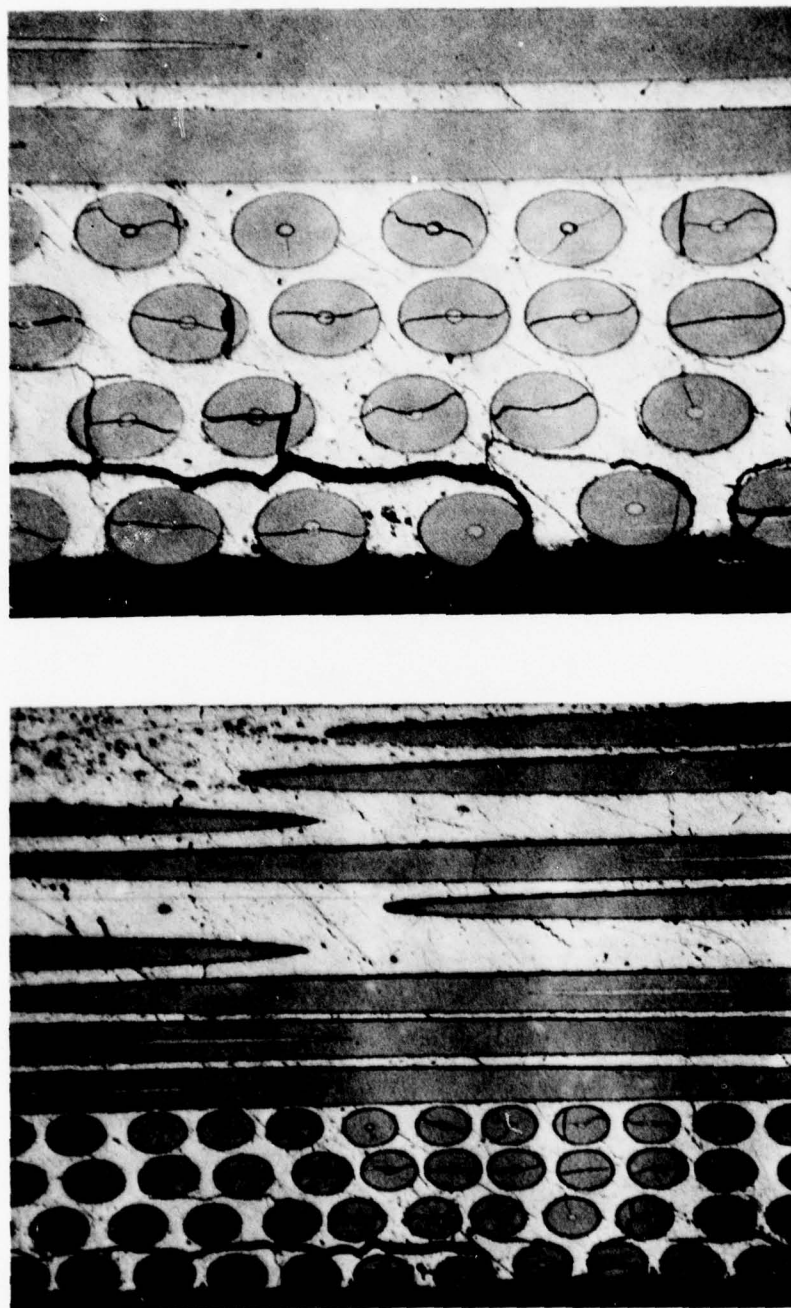
Figure 9.4-8 Microstructure of Component Borsical<sup>®</sup> Specimen (7F/B-H4) that was High Frequency Fatigue Tested at 450° F and 1755  $\mu$  in./in. for  $2 \times 10^6$  Cycles

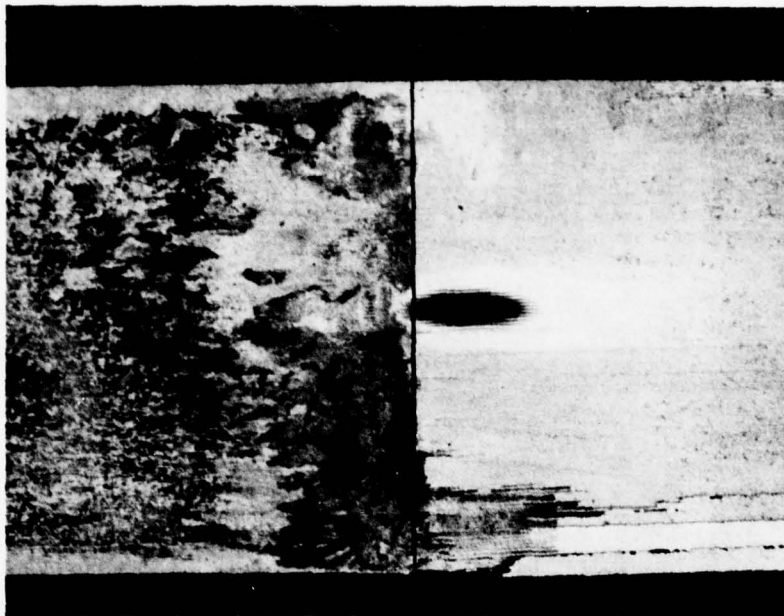
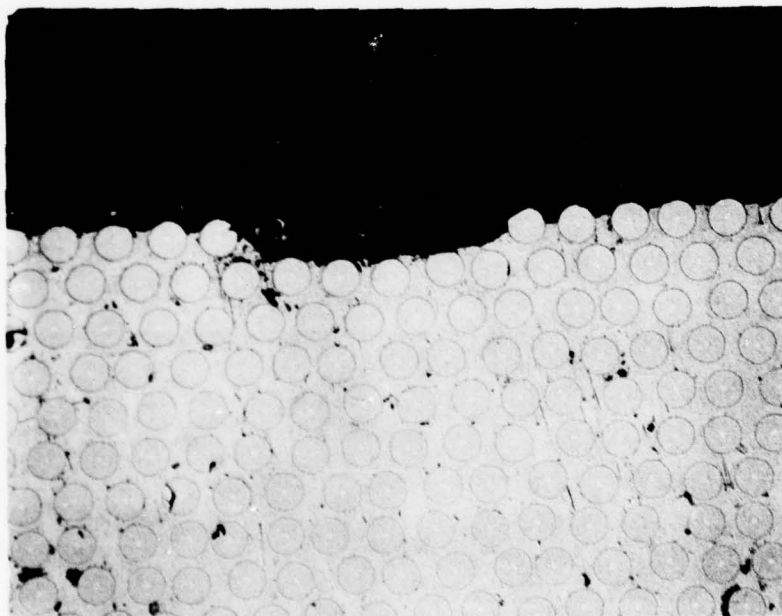
The microstructure of eroded (exposed fibers) 70°F HFF-tested unidirectional specimens was similar to that for undamaged specimens. As shown in Figure 9.5-2, failure takes place by surface delamination with no internal fatigue cracks. Eroded unidirectional specimens HFF-tested at 450°F also looked identical to the undamaged specimens. The delamination did not occur preferentially at the eroded region even when cycled to 100 percent of life expectancy at either room temperature or 450°F. A deeply eroded sample with broken fibers was HFF tested at 450°F and did delaminate from the damaged area as shown in Figure 9.5-3. Erosion damage also did not alter the failure mode for component specimens. As with undamaged specimens, the 450°F HFF test resulted in splitting of the cross-ply layers and surface delamination as shown in Figure 9.5-4. It should be noted that, again, delamination did not originate in the eroded area of exposed fibers. A deeply eroded component specimen (fibers broken during erosion) behaved in a 450°F HFF test as though there were no broken fibers, and specimen delamination did not begin at the eroded area, as shown in Figure 9.5-5.

*Figure 9.5-2 Typical Unidirectional Erosion Test Specimen Following Erosion and High Frequency Fatigue Testing Showing Lack of Delamination in the Eroded Region.*

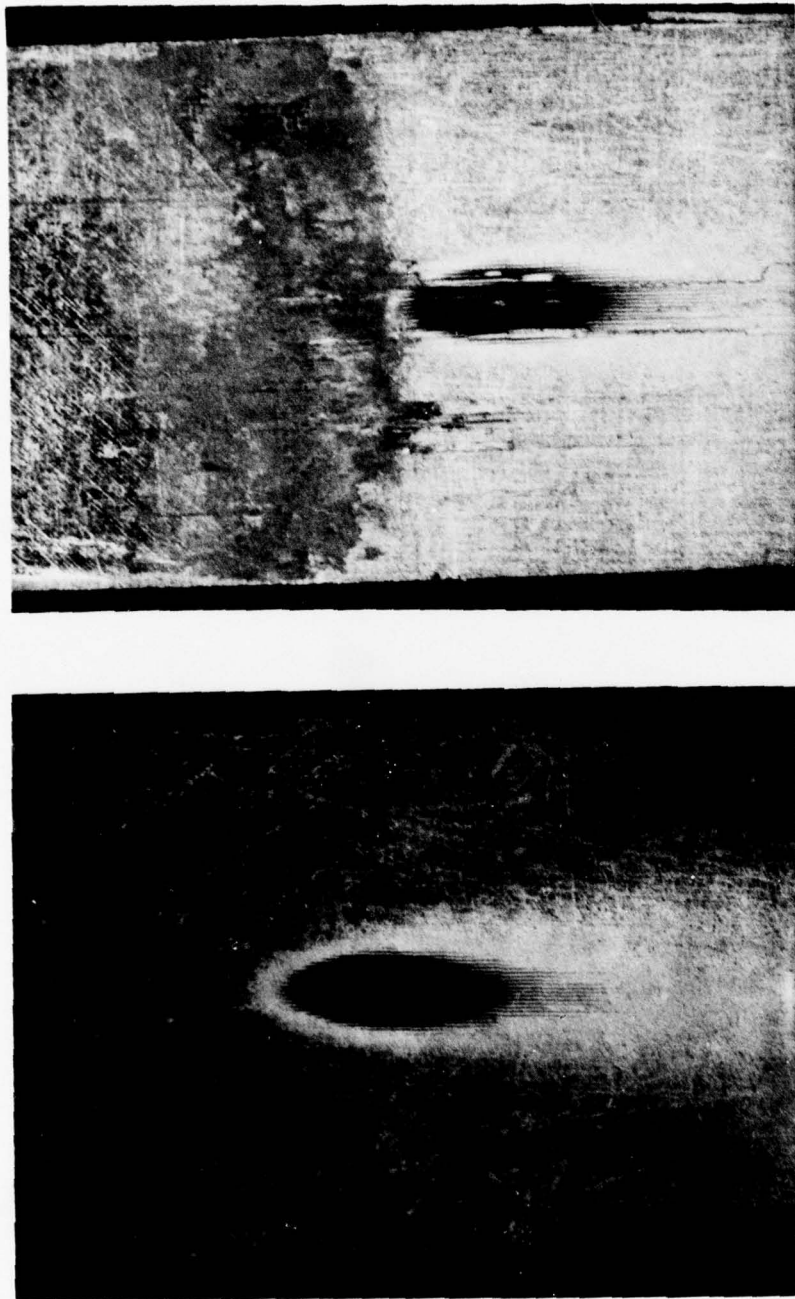
Figure 9.5-3 Surface of Deeply Eroded Unidirectional Borstical<sup>®</sup> Specimen (3E/u-H3) Before (Left) and After (Right) 450°F High Frequency Fatigue Testing at 2100  $\mu$  in./in. for  $5 \times 10^6$  Cycles

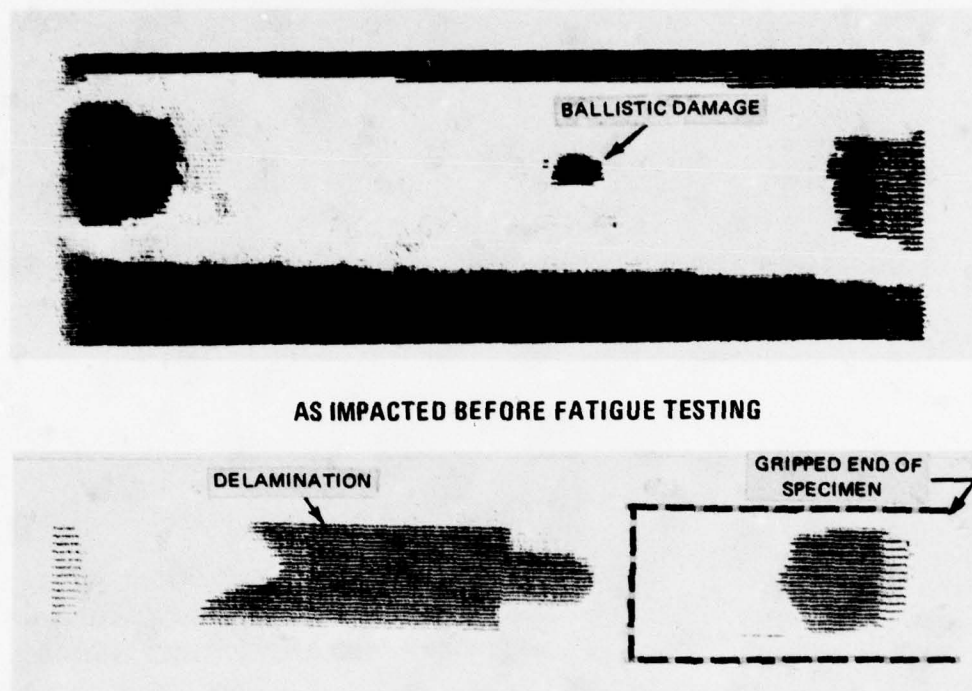
Ballistic impact damage drastically lowered the HFF life of the unidirectional and cross-ply configurations as shown in Table 9.6-II. However, impact damage did not significantly reduce the HFF life of the component material specimens. C-scan results, shown in Figures 9.6-2 and 9.6-3, show that delamination failures in the unidirectional specimens are initiated at the impact area while the delamination failures in the component specimens extend from the grip edge (similar to undamaged specimens) up through the impacted region. This would indicate that the failures do not emanate from the impact area in the component specimens. Cross-ply laminates suffer a drop in natural frequency due to impact damage but no delamination occurs.

*Figure 9.6-2 Ultrasonic C-Scan Test Results for Ballistically Impacted Unidirectional Specimen (3A/u-H2) Before and After High Frequency Fatigue Testing Showing Delamination That Occurred During Fatigue Testing.*

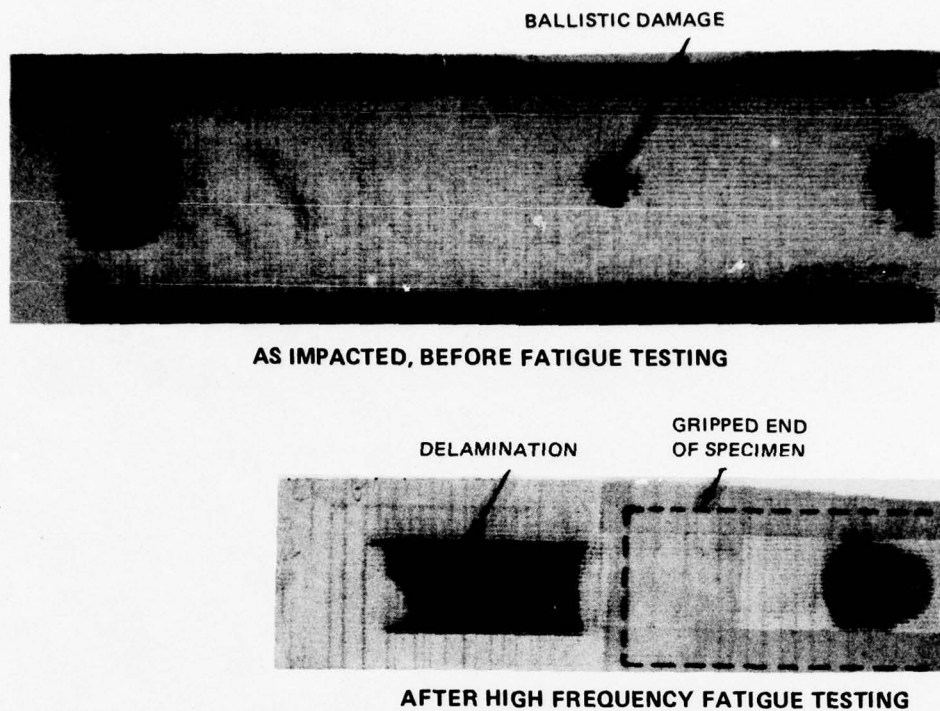
*Figure 9.6-3 Ultrasonic C-Scan Test Results for Ballistically Impacted Component Specimen (7B/B-H4) Before and After High Frequency Fatigue Testing Showing Delamination that Occurred During Fatigue Testing*

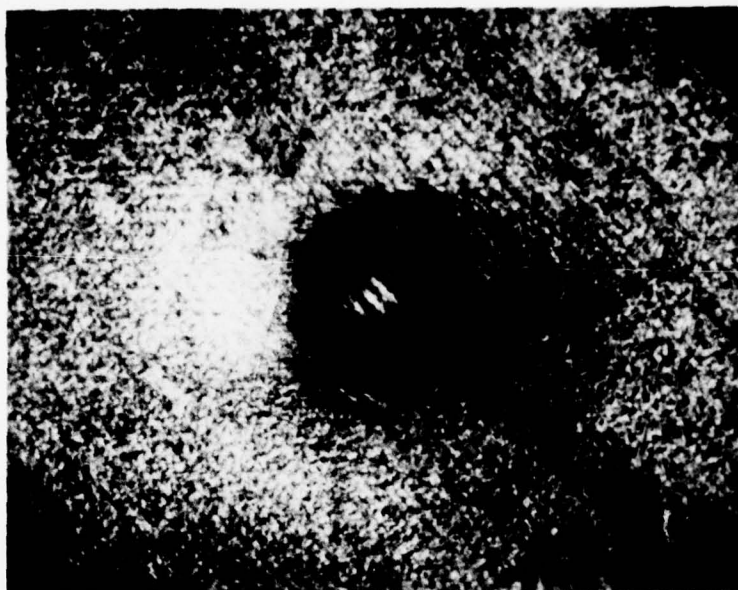
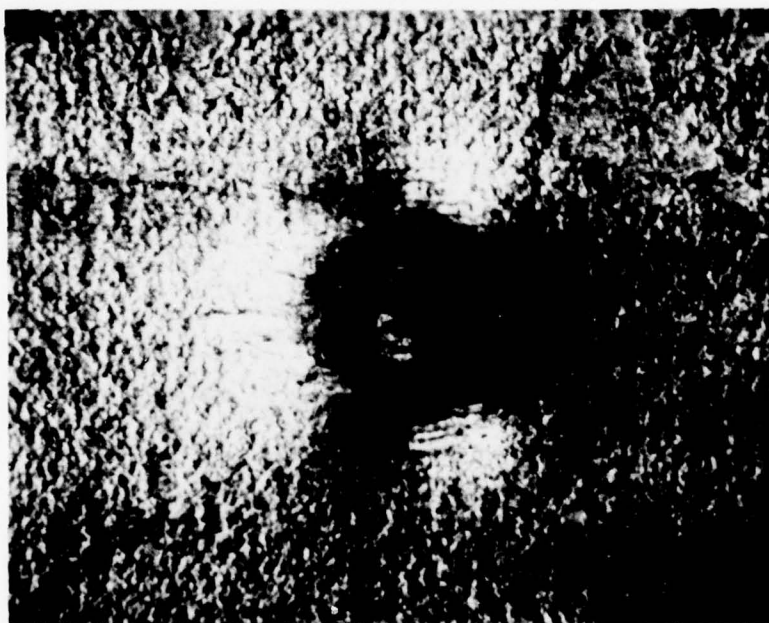
Figure 9.10-1 Impacted Area of 20-Layer Borsical<sup>®</sup> Test Specimens Prior to Repair

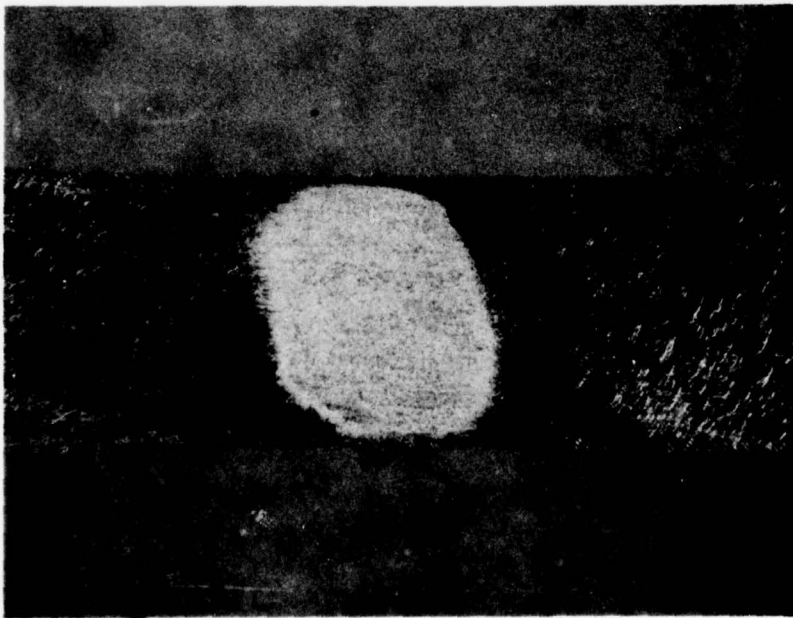
Figure 9.10-3 Twenty-Layer Borsical® Test Specimen as Repaired with Aluminum/Silicone Resin (Left), and After 100 Hours at 500°F in Air. Slight Discoloration is Apparent

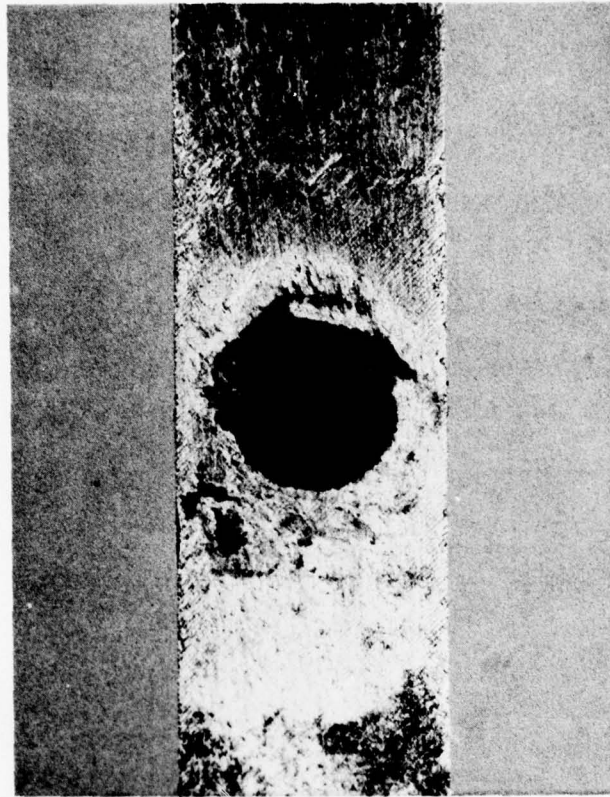
*Figure 9.10-4 Typical 20-Layer Borsical<sup>®</sup> Test Specimen After Repair with Polyimide/Graphite Composite*

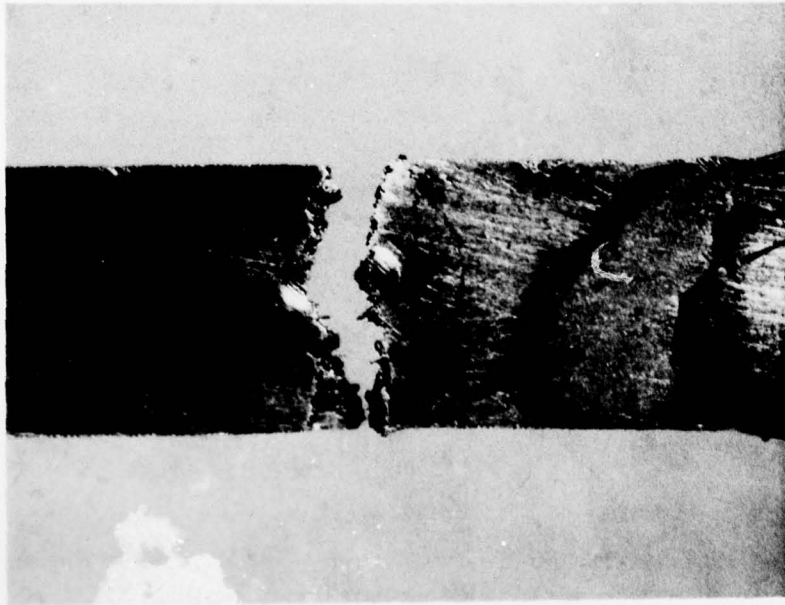
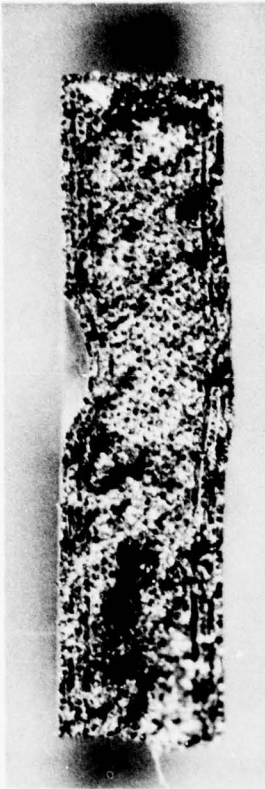
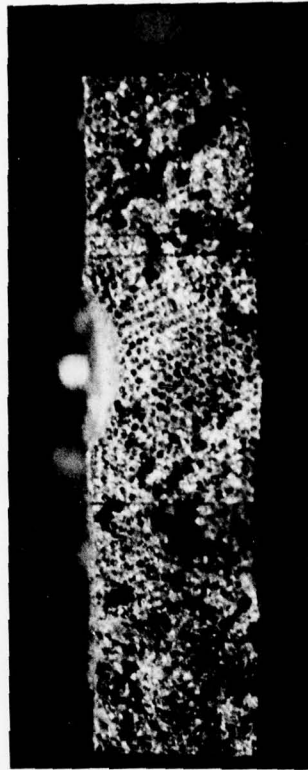
The fracture surfaces of post-tensile test as-damaged specimens versus damaged and aluminum/silicone resin repaired specimens are shown in Figures 9.10-7 through 9.10-11. Examination of these fractures revealed that complete filling with aluminum/silicone is more difficult when the damaged material is leached away. Also note that the failures of the leached and repaired samples resulted in extensive pull-out of the aluminum/silicone filler compared with the samples repaired in the as-damaged condition. Based on ease of repair and retention of the aluminum/silicone filler, no leaching should be done prior to repair.

Figure 9.10-7 Typical 20-Layer Borsical<sup>®</sup> Test Specimens After Testing in the As-Impacted Condition Without Repair

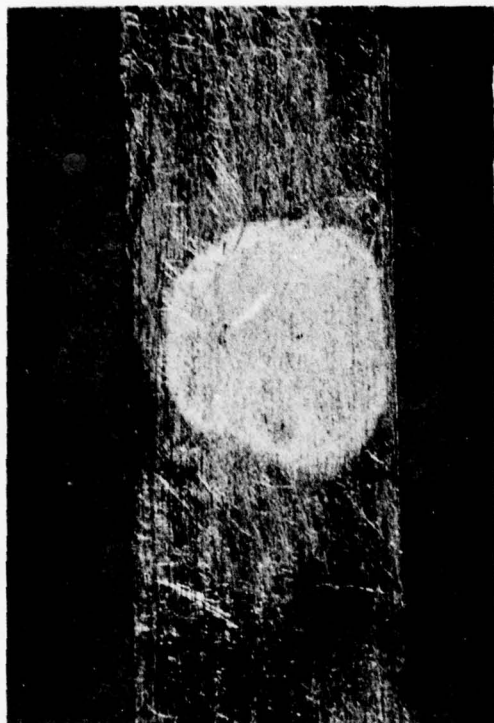
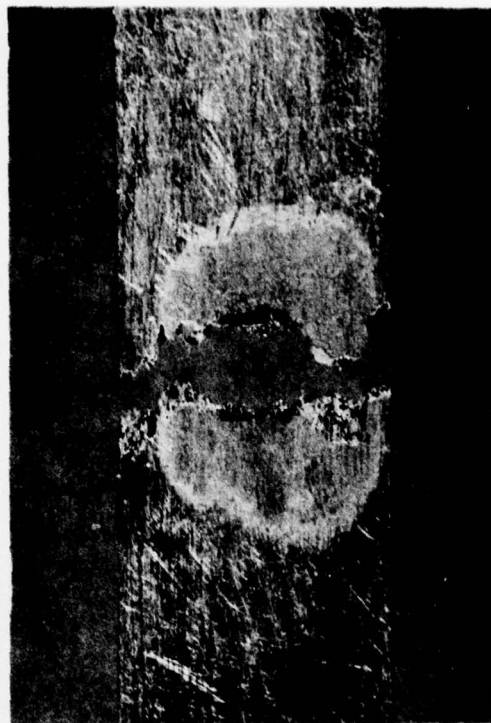
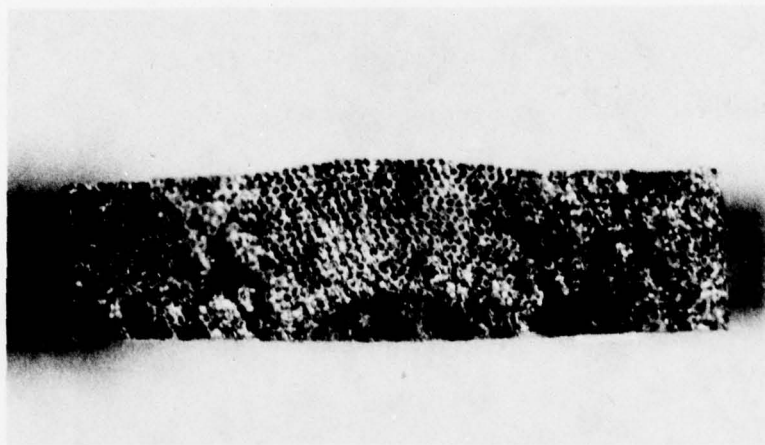
Figure 9.10-8 Typical Unidirectional ( $0^\circ$ ) 20-Layer Borsical<sup>®</sup> Test Specimen as Repaired with Aluminum/Silicone (Top Left), and as Tensile Tested

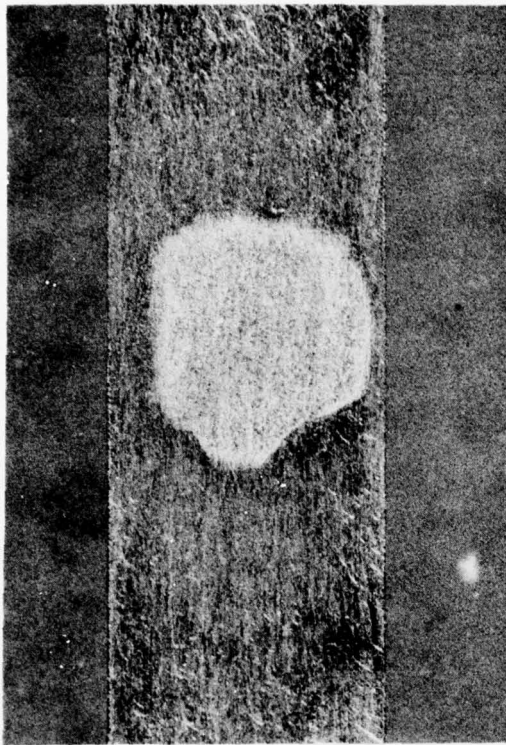
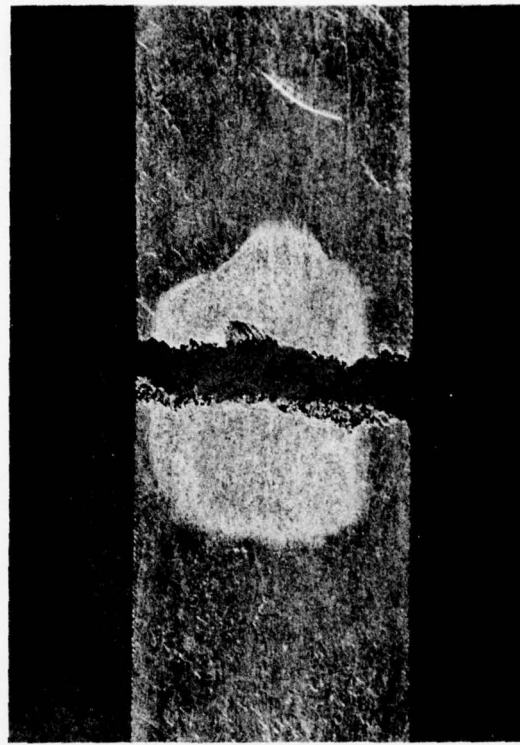
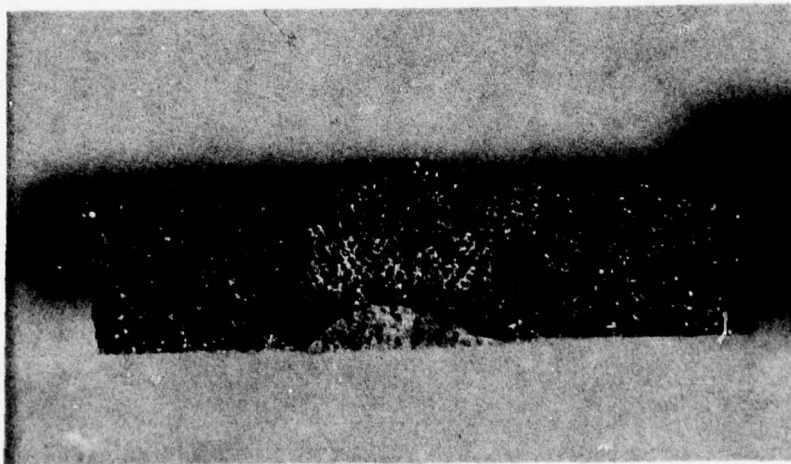
**Figure 9.10-9** Typical Component Configuration ( $\pm 45^\circ$ ,  $0^\circ$ ,  $\pm 45^\circ$ ), 20-Layer Borsical<sup>®</sup> Test Specimen as Repaired with Aluminum/Silicone (Upper Left), and After Tensile Test. No Leaching Prior to Repair

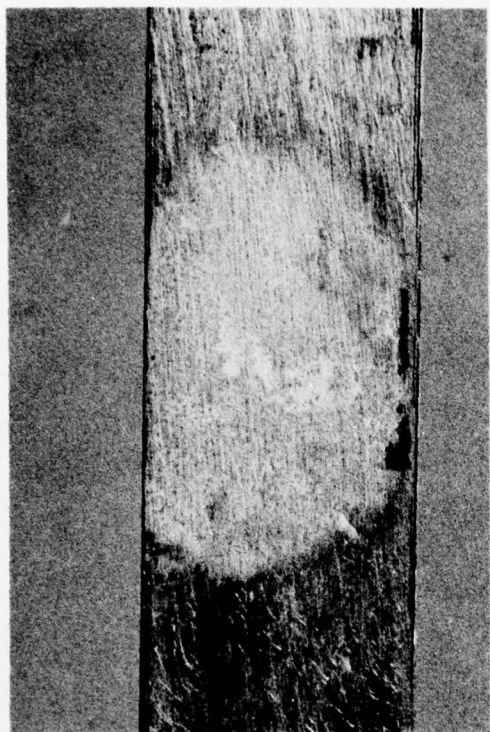
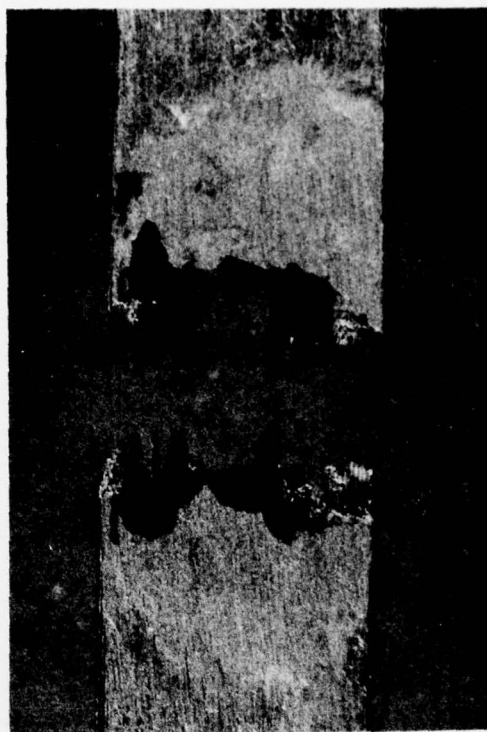
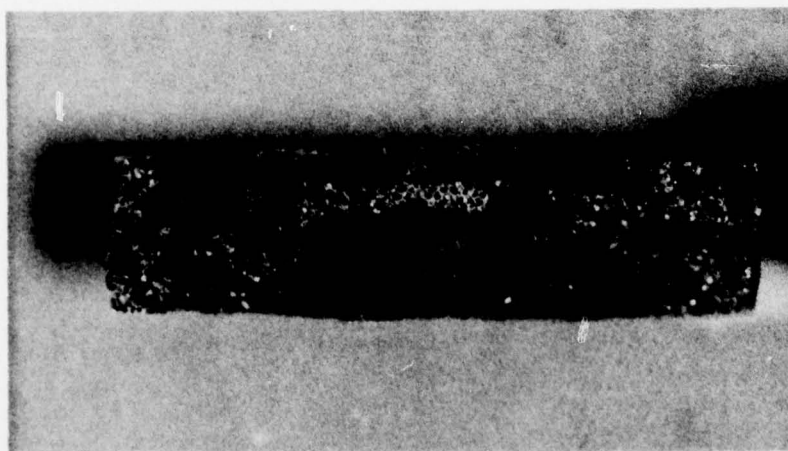
*Figure 9.10-10 Typical Unidirectional (0°) 20-Layer Borsical<sup>®</sup> Test Specimen as Repaired with Aluminum/Silicone and After Tensile Test. Damaged Area Removed by Leaching with HCl Prior to Repair*

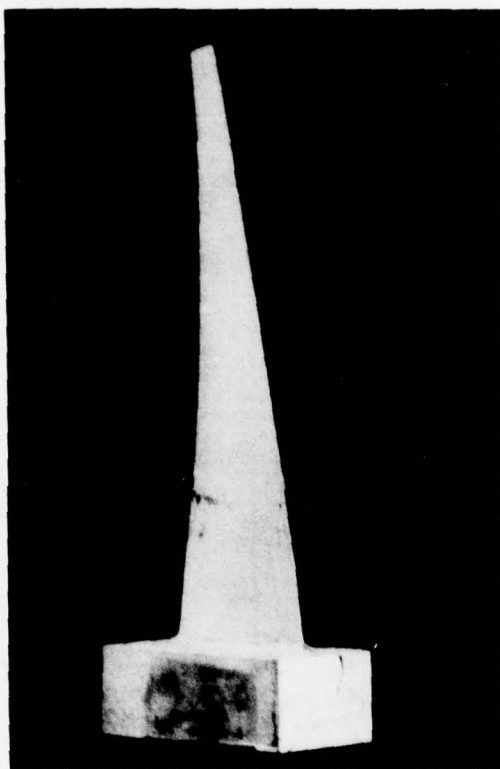
*Figure 10.2-1 The BORSIC<sup>®</sup>/Aluminum Blade Showed No Evidence of Significant Salt Corrosion After an Elevated Temperature (500°F), 100-Hour Salt-Stress-Corrosion Test*

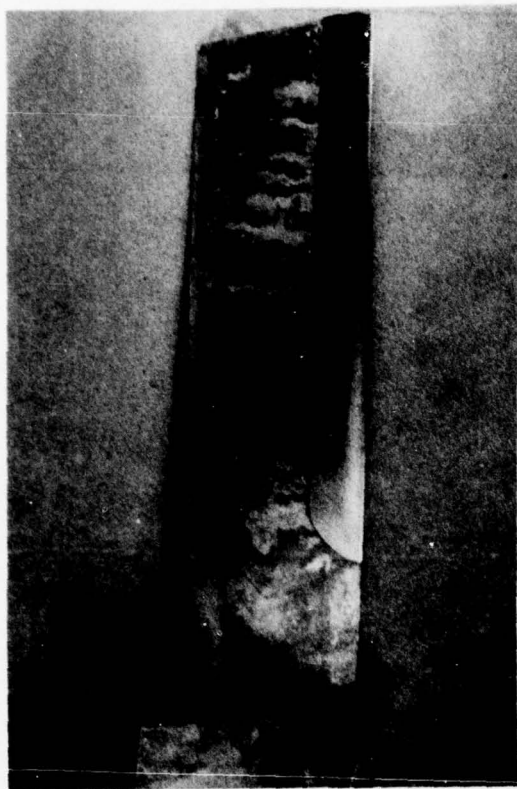
Figure 10.2-2 Inspection Showed No Discernable Degradation of the BORSIC<sup>®</sup>/Aluminum Blades After a 100-Hour Salt-Stress-Corrosion Test Under Humid Conditions at 90°F

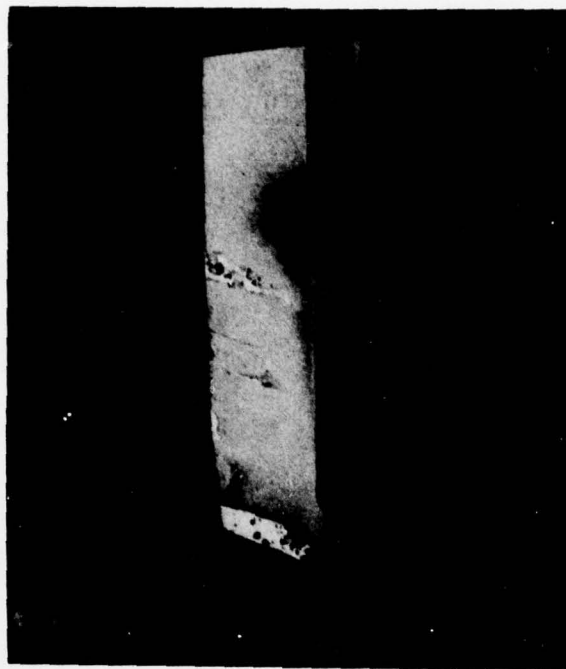
*Figure 10.2-5*      *Concave Side of Composite Fan Blade D-17 Showing Condition After FOD Spin Test. N - 10,360 rpm, T = 70°F, FOD With 75 grams of Sand (XPN-26814)*

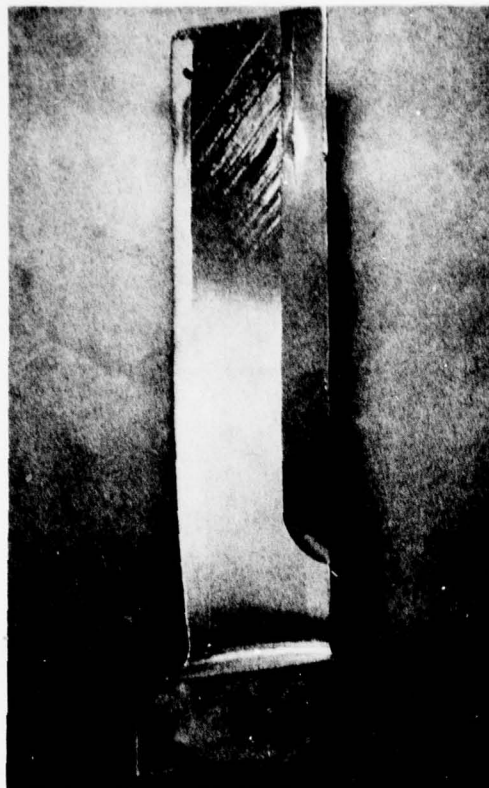
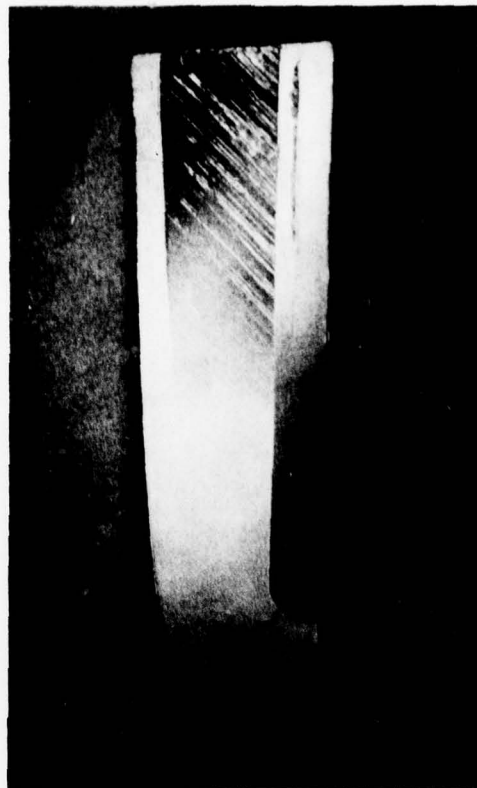
BLADE S-14 ERODED WITH 100 LB  
SAND AT 3 LB/MIN

BLADE S-28 ERODED WITH 360 LB  
SAND AT 1 LB/MIN

*Figure 10.2-7 BORSIC<sup>®</sup>/Aluminum Blades Following Erosion Tests*

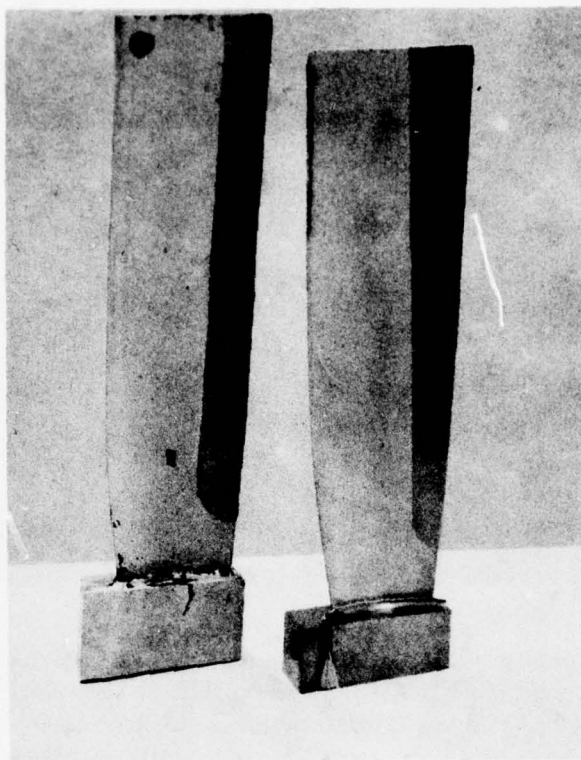
*Figure 10.2-8 Comparison of Composite Blades With Nickel-Cobalt Leading Edge Protection; Blade on Right Has Increased Protected Area*

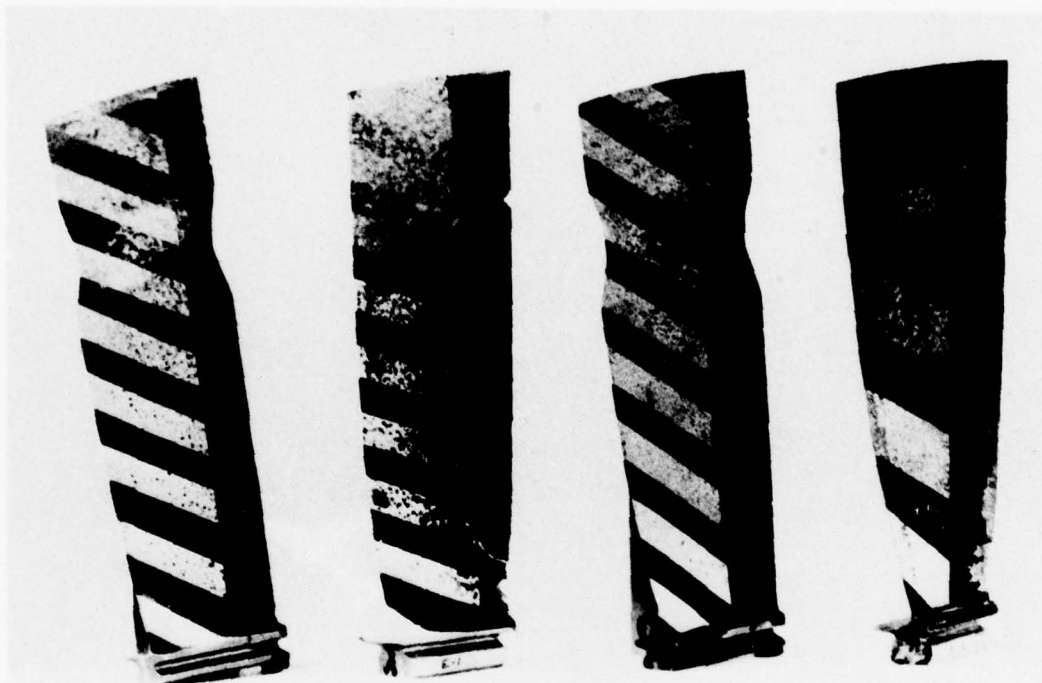
*Figure 10.2-13 Comparison of Concave Sides of Bill-of-Material Titanium Fan Blades and BORSIC<sup>®</sup> Fan Blades After 66 Strikes per Blade With 1/4-Inch Quartz Gravel at Room Temperature and at 10,360 rpm*

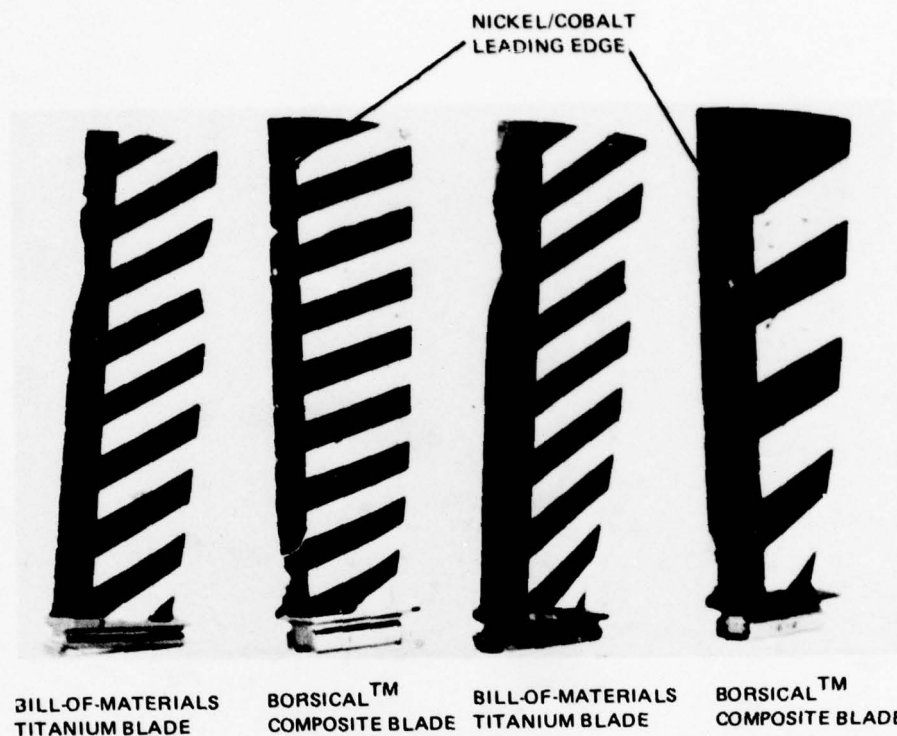
Figure 10.2-14 Comparison of Concave Sides of Bill-of-Materials Titanium Blades and BORSICAL® Fan Blades After 66 Strikes per Blade With 1/4-Inch Quartz Gravel at Room Temperature and 10,360 rpm

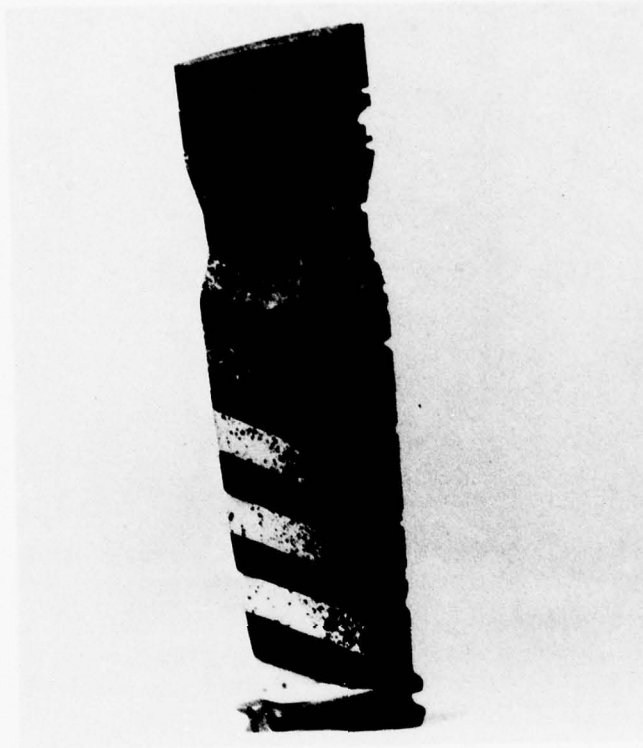
*Figure 10.2-15    Appearance of Bill-of-Material Titanium Fan Blade After 23 Strikes With ½-Gram Steel Rivet at Room Temperature and at 10,360 rpm.*

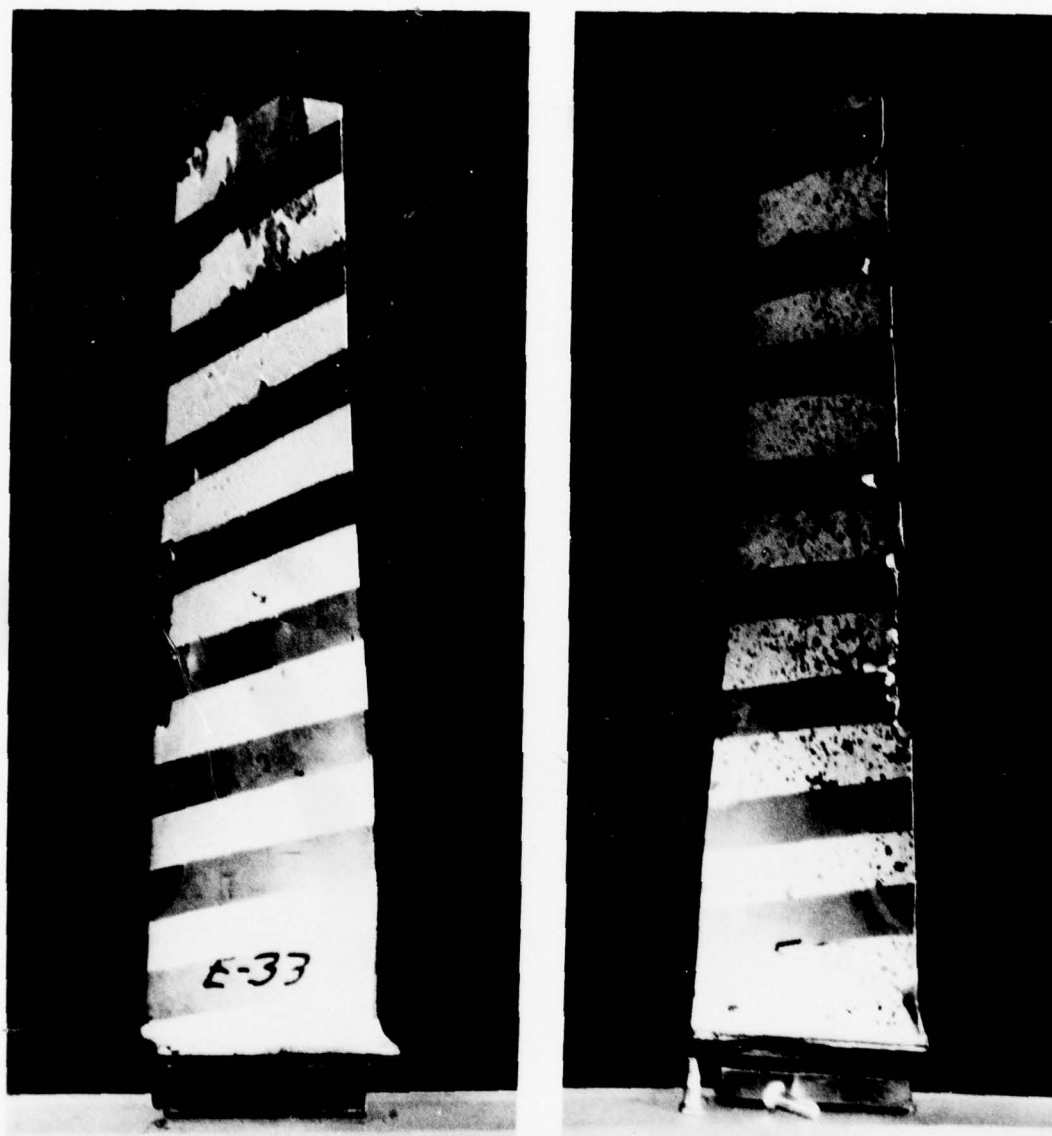
Figure 10.2-16 Appearance of BORSIC<sup>®</sup> Aluminum Fan Blade After 23 Strikes With 1/2-Gram Steel Rivet at Room Temperature and 10,360 rpm. Lost material was about twice that of titanium blade.
